Manhole Inspection Summary

Manhole # S27E__045MH

Insp Date: **8/10/09 1:51 PM**

Location Address: **751 FREMONT AVE**

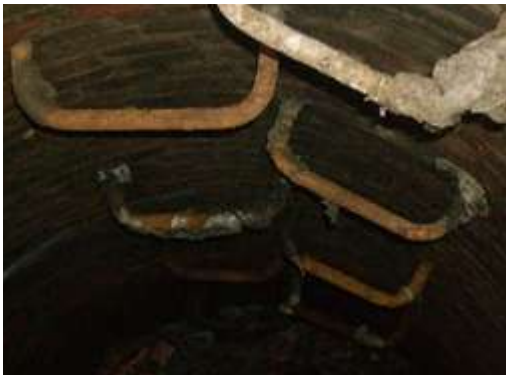
Defect 2

Count: **9** Missing: **0** ☒ **Corroded**

☒ **Evidence Of Surcharge** Depth: **6** (ft.) ☐ Active Surcharge Present

CORRODED STEPS ALONG WITH
SURCHARGE EVIDENCE

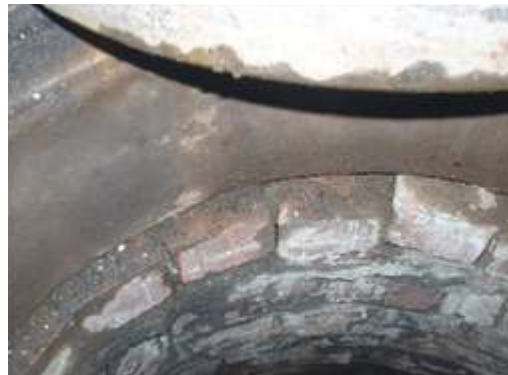
Defect 1

Offset: **1** (in.)

FRAME OFFSET

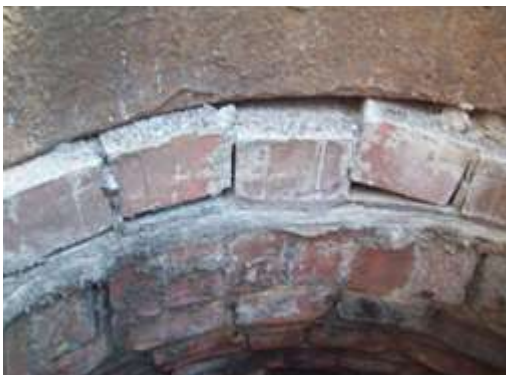
Defect 3

Condition: ☐ Sound ☐ Cracked ☐ Root Intrusion ☒ **Loose Brick** ☐ Deteriorated

LOOSE BRICKS ON CHIMNEY

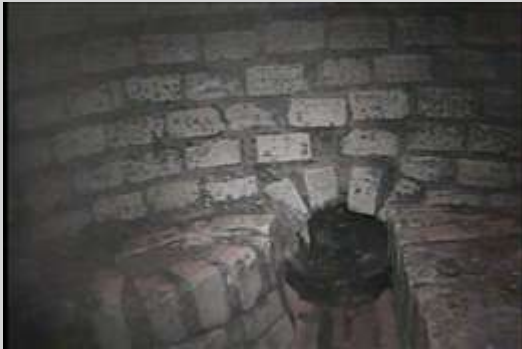
12 O'Clock Outflow

Pipe Height: **8.4** (in.) Rod and Bar (Angled)
Pipe Material: **Clay** ☐ Pipe Lined
Invert Depth: **15.38** (ft.) Flow Characteristics: **Slow**
Deposits: ☐ None ☐ Mud ☐ Sludge ☒ **Debris** ☐ Grease
Silt Depth: **2** (in.) Deposits Extent: **Light**
Infiltration: **None** Pipe Seal Cond: **Broken**

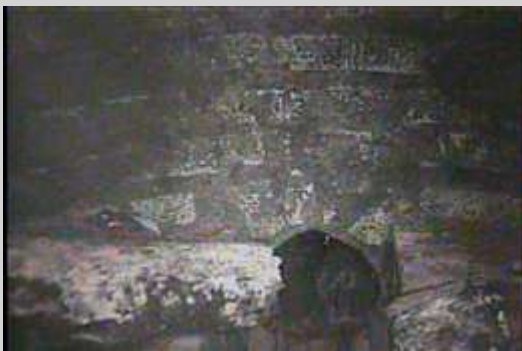
6 O'Clock Inflow

Pipe Height: **8.4** (in.) Rod and Bar (Angled)
Pipe Material: **Clay** ☐ Pipe Lined
Invert Depth: **15.23** (ft.) Flow Characteristics: **Slow**
Deposits: ☐ None ☐ Mud ☐ Sludge ☒ **Debris** ☐ Grease
Silt Depth: **1** (in.) Deposits Extent: **Light**
Infiltration: **None** Pipe Seal Cond: **Broken**

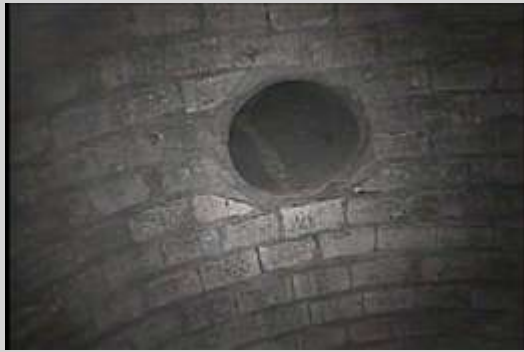
9 O'Clock Inflow

CORRODED STEPS ALONG WITH
SURCHARGE EVIDENCE

Silt Depth: **7** (in.) Deposits Extent: **Heavy**

Drop Condition: **Clogged**

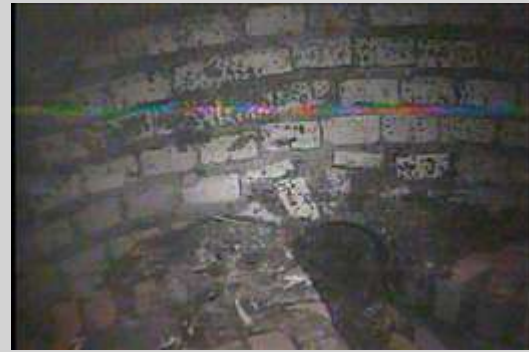
CORRODED STEPS ALONG WITH
SURCHARGE EVIDENCE
